1 Repair instructions/occurring faults

2 Paint damage on front panel unit

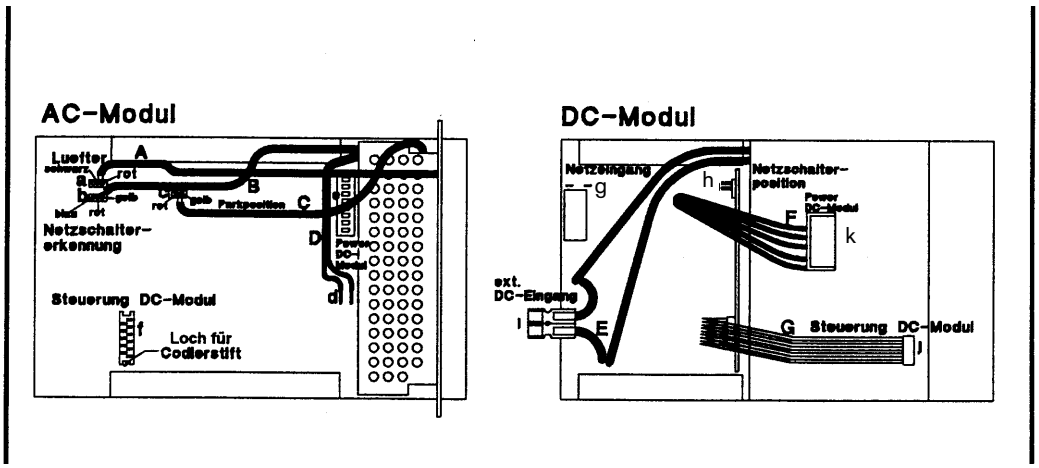
Fig. 1: DC module connector

1. When the unit is switched on the audible power failure alarm sounds, even though mains power is connected. The unit is not operational.
   –> Connector k of DC module is faulty or not plugged in.
2. The DC module exhibits no function when the mains voltage fails. The audible power failure alarm sounds.
   –> Connector h not plugged into DC module or rechargeable batteries defective.
3. When the unit is switched on the warning: «Xef28»Int. battery...«Xaa» appears even though the mains power is connected.
   –> Connector g (FASTON) not swapped over in installation or faulty.
4. No mains power or battery symbols are shown on the display. No alarm is delivered in operation with the internal or external rechargeable battery. The power failure is only signalled, by the audible power failure alarm, when the internal battery has discharged.
   –> DC module option not activated (code '4811')
